EARLY FAILURE MECHANISMS IN ALUMINIUM CELL CATHODES

Elkem Research
N-4602 KRISTIANSAND, Norway

Elkem Aluminium Lista
N-4551 FARSUND, Norway

ABSTRACT

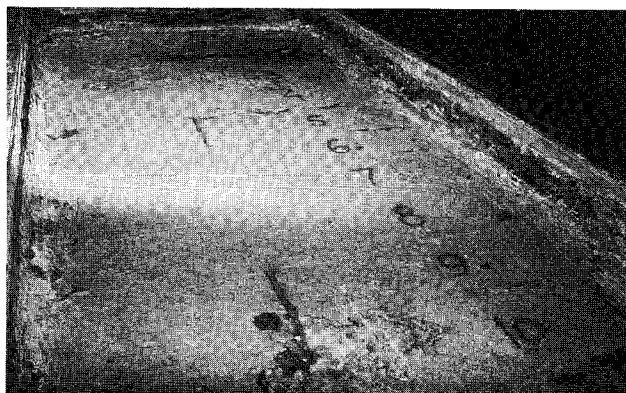
Resistor baking of pots, using a coke bed as resistor material between anode and cathode, is probably the most common preheating method, especially in prebaked anode cells. Poorly executed this method can, however, subject the bottom blocks to severe thermal shocks, with temperatures up to 1500°C and thermal gradients of 1100°C/m at the carbon surface of the cathode [4]. Poor anodic current distribution during preheating may often be seen directly as red studs or anode cracking, but the condition of the underlying bottom block can be equally poor, although often not spotted due to the coke cover. Such preheating cracks (Figure 1) in

Figure 1. Preheating cracks (in bottom blocks no. 5 and 9) in failed cathode. Cracks are painted in order to mark them on photograph. Coke resistive preheating on full line load. Pot life was 446 days.

one or more blocks is probably more a rule than a freak accident if cathodes with amorphous bottom blocks are resistor baked on full line load. Shunting or replacing amorphous block qualities with more graphitic ones will reduce or remove this problem.

The procedure that most effectively may reduce or avoid thermal shock cracking during resistive preheating is by shunting the pot. Other remedies can be reducing the differences in resistivity of the

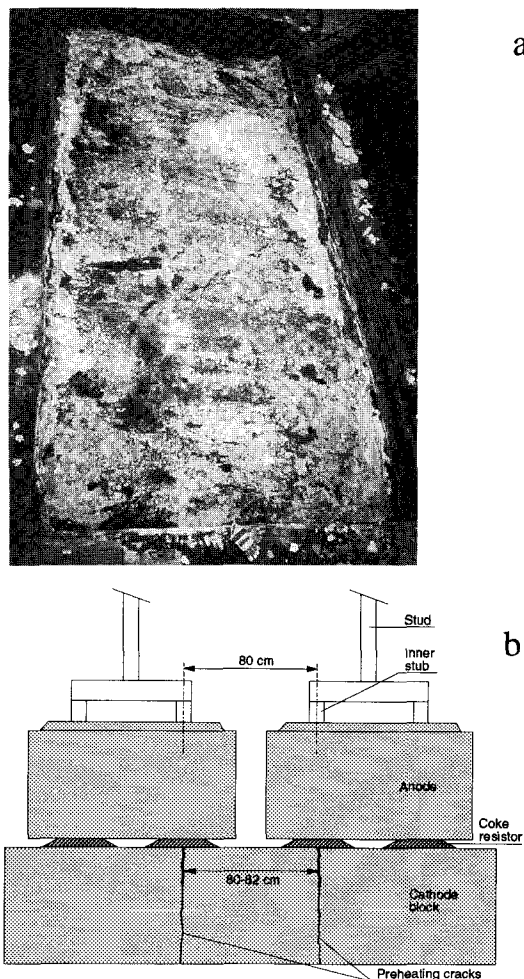
Figure 2. Photograph (a) shows cathode surface with two parallel lines of preheating cracks, spaced 80-82 cm apart, running through all bottom blocks. Cracking pattern corresponds exactly to inner stub-stub distance (b) and observation that major part of current initially passes through the inner stubs. Pot life was 1233 days.

Although one or two blocks may crack due to poor current distribution, more extensive cracking during preheating is most often due to unsatisfactory carbon quality. Figure 2a shows a photograph of a cathode surface in which every bottom block had experienced two preheating cracks, seen as two parallel lines running down the length of the cathode bottom. As the current distribution inevitably is somewhat uneven some cathode blocks are being subjected to much lower current densities than average. Normal quality blocks subjected to lower-than-average current densities should not crack, hence a cracking pattern as shown in Figure 2a is caused by inadequate thermal shock resistance of the entire bottom blocks lot. The distance between the parallel cracks was measured to 80-82 cm, corresponding almost exactly to the inner stub-stub distance of the anodes in the cell (Figure 2b) and in agreement with the observations that the major part of the current is passing through the inner anode stubs during the initial preheating period.

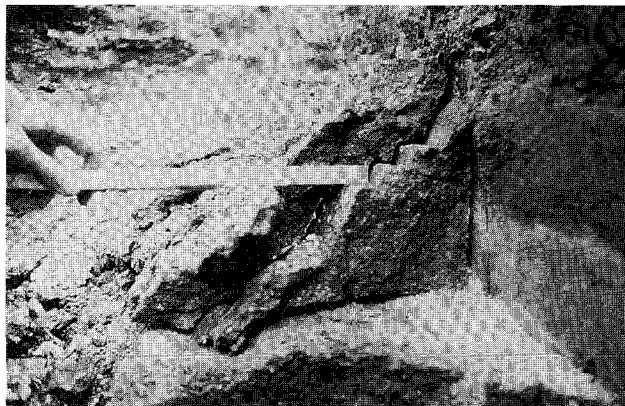
Autopsies of failed cathodes have shown that a disproportionate number of early failures, *i.e.* pot lives less than 2-3 years, are caused by weaknesses in the rammed parts of the carbon lining [5]. Such failures are either caused by improper paste installation, bake-out or cell operation, in addition to poor thermomechanical characteristics of the paste itself.

Possibilities for later pot failures introduced during installation may be caused by improper ramming procedures as well as poor paste properties. Unsuccessful compaction will yield baked parts with low mechanical strength and excessive amounts of coarse porosity,

Figure 3. Photograph of peripheral paste incline shows stratification and lack of binding between paste layers caused by extensive crushing of paste surface particles during compaction (grooves from serrated wheel of compaction machine). Pot life was 314 days.

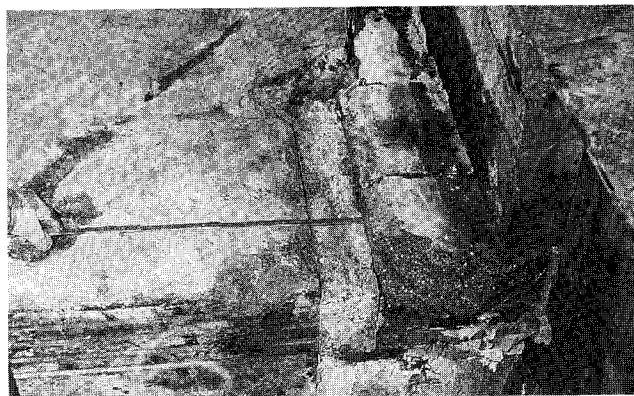
Figure 4. Loss of parts of the peripheral seam incline caused by stratification in upper part of seam. The photograph also illustrates the poor bonding between prebaked carbon (filler block and sidewall block) and rammed parts. Pot life was 9 days.

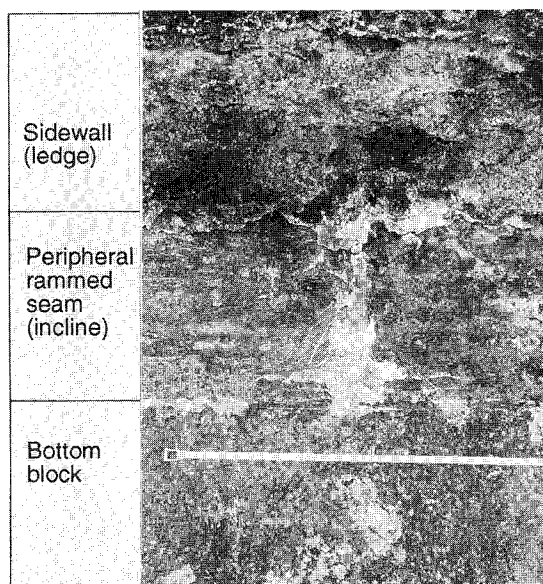
High paste shrinkage, especially in the more bulky peripheral joint, can result in vertical crack opening and be detrimental to pot life. For pastes with very poor shrinkage characteristics such shrinkage cracks have been found with less than 1 meter spacing almost along the entire periphery of the cell. Assuming a paste with 0.4 % net shrinkage, which is quite normal but far in excess of what should be tolerated, the total crack width for each running meter could amount to as much as 4 mm. Figure 5 shows a photograph of such a shrinkage crack in the peripheral seam.

Figure 5. Vertical crack in peripheral seam filled with bath and metal. Pot life was 350 days.

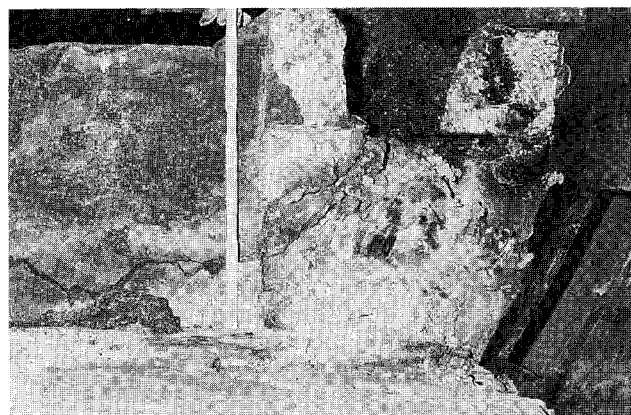
The rammed peripheral seam has often been found to be the weakest part of the lining, through which massive amounts of bath and metal can drain into the interior in early life. Figure 6 shows an autopsied cathode where the fatal failure, a typical vertical shrinkage crack in the peripheral seam, had developed. A massive cone of solidified aluminium metal can be seen below the crack, among reacted and

collapsed refractory and insulation materials. Several tons of metal and bath had flowed further down into the cathode, destroying more bottom insulation on its way.

Figure 6. Cathode failure caused by massive bath and metal penetration through shrinkage crack (surface covered with frozen bath and metal) in peripheral seam. Pot life was 5 days.

The rammed joints between the bottom blocks do usually not develop these shrinkage cracks. These joints are only a few centimeters wide and the frictional forces between the paste and the prebaked blocks are high enough to distribute the shrinkage stresses in such a way that rather a large number of microcracks will develop than a few major cracks. In addition to choosing ramming pastes with more acceptable shrinkage characteristics, similar narrow peripheral seams could be used to minimize the possible development of fatal shrinkage cracks.

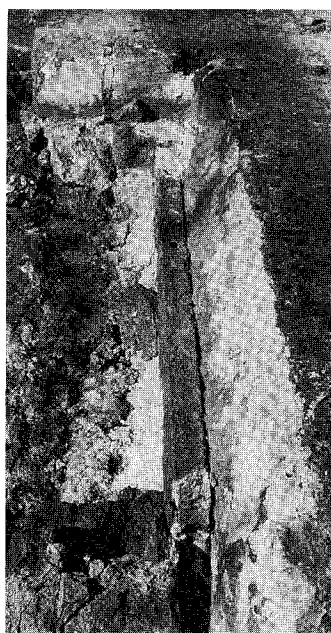
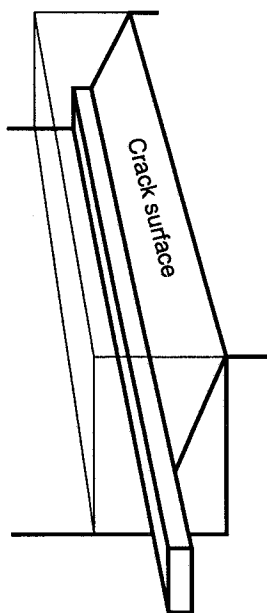
Figure 7. Cathode failure caused by angled crack in bottom block. Top of bottom block removed to expose crack surface. Partially dissolved collector bar in foreground. Pot life was 1032 days.

will experience an excessively high cathodic voltage drop and high energy consumption. Figure 7 shows a crack running along the entire length of a bottom block from the top of the collector bar to the cathode surface. The top of the block has been removed and a typical crack surface, covered with aluminium carbide and fluorides is seen. Part of the collector bar has been dissolved and replaced with frozen bath.

The best remedy for avoiding a fatal wing crack failure is to adjust the geometries of the slot and collector bar to the combined thermomechanical movements of the sealant, bottom block and bar. While the contact pressure during early operation should be large enough to minimize cathodic voltage drop and to avoid the possibility of any early bath or aluminium metal penetration, it should not exceed the critical of the carbon block. If cast iron is used to seal the bar proper preheating of collector bar and block prior to sealing is also very important.

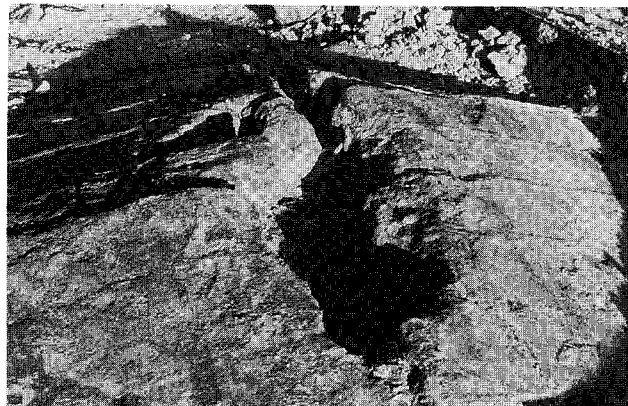
Figure 8. Buoyancy displacement of large parts of carbon bottom caused by extensive horizontal shear failures in bottom block wings. Pot life was 21 days.

More extensive wing failures, especially of the shear type failure may have dramatic consequences. Figure 8 shows the cleaned surface of a failed cathode where large parts of the carbon bottom pane above collector bar level became detached and floated to the anode working surface.

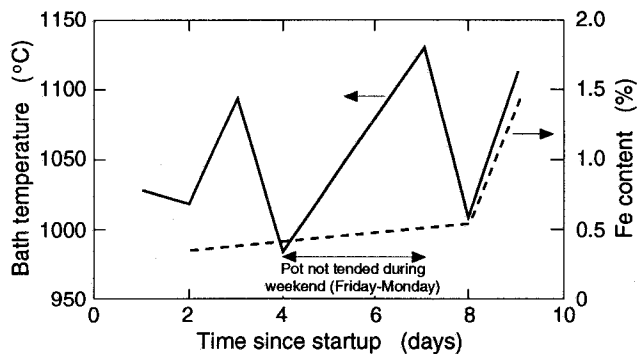
Figure 9. Recorded temperature and iron contamination in a pot that failed only 9 days after start-up. High transient temperatures had led to gap opening between bottom blocks and peripheral rammed paste.

The development of temperature and metal iron content in a pot that failed after only 9 days is shown in Figure 9. After an transient high temperature three days after start-up the pot was brought back to normal conditions before a week-end. Lack of proper attention during the week-end brought the temperature up to $\approx 1130^{\circ}\text{C}$, leading to pot failure from excess iron contamination when brought down again. A later autopsy of the cathode revealed that gaps had opened between bottom blocks and the peripheral rammed seam along one side of the pot, thus giving aluminium metal rapid access to the current collector bars.

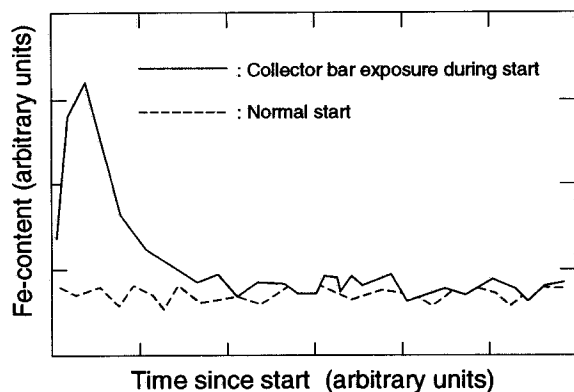
Figure 10. A transient increase of the iron content in the aluminium metal after start-up is an early warning signal that a metal leak into the interior of the lining has taken place (from [1]).

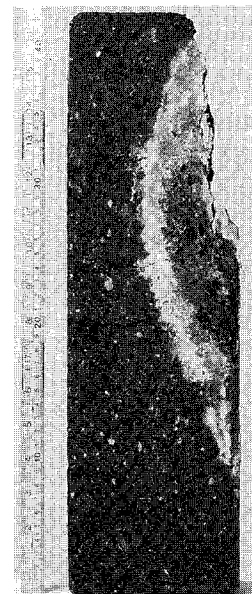
Apart from minor sodium-induced surface spalling (Figure 11) it is often hard to point to fatal failures that directly can be related to the sodium expansion of the carbon materials since other types of materials degradation and failure may shroud the failure sequence. However, there are examples of almost complete disruption of most of the carbon bottom (amorphous blocks above current collector bar level) by enormous amounts of minor horizontal exfoliation-like cracks that it is difficult to explain otherwise.

Figure 11. Sodium-induced surface exfoliation of amorphous sidewall carbon. Pot life was 111 days.

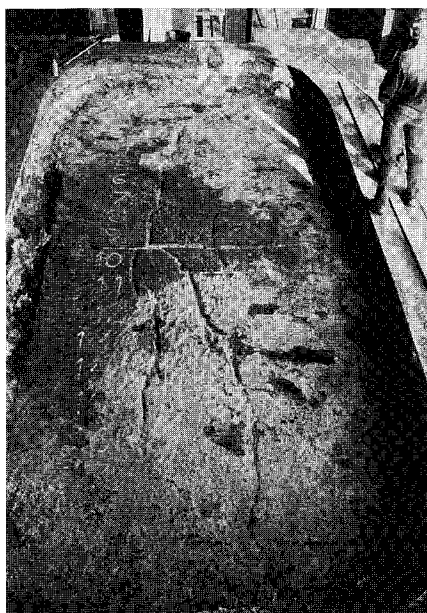
Considerable amounts of aluminium carbide may also be formed by reaction between aluminium metal and the lower parts of the cathode block. This reaction can be especially damaging if metal leaks forces the critical isotherms up into the carbon block and a slow feed of aluminium metal and fluorides is maintained. The last requisite is almost self fulfilling, since bottom heave generates leaks that generates more bottom heave, and so on in a vicious circle. The pressure that forces the bottom blocks up will also tend to flex them, ultimately resulting in fatal crack formation and exposure of current collector bars to the metal pad (Figure 12).

Figure 12. Failed cathode with extensive cracking pattern in carbon lining caused by bottom heave. Pot life was 501 days.

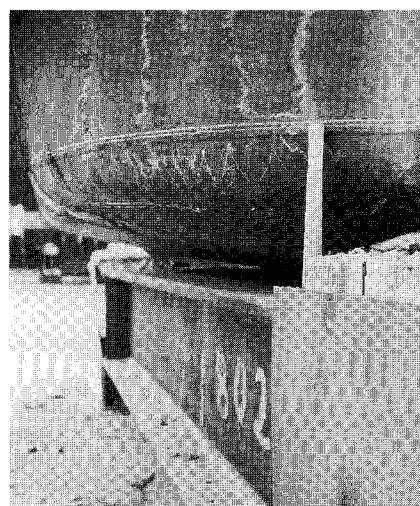
The pressure that forces the bottom blocks upwards results in a counterpressure of similar magnitude directed downwards. The deckplate around the periphery of the pot and the strength and stiffness of the casing itself and supporting structure will counteract these vertical movements. Weak pot shells with no or inadequate supporting structure can be badly deformed in the bottom heave process. The photograph in Figure 13 shows the deformation of the peripheral parts of the steel shell bottom, caused by the resulting forces of an upward pressure acting on the deckplate and a downward counterpressure acting under the carbon bottom pane.

Figure 13. Bottom deformation of a weaker type self-supporting steel shell following bottom heave. Pot life was 742 days.

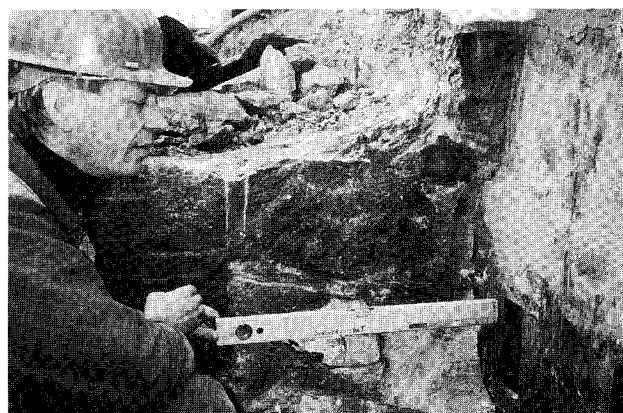
In cathodes having stronger and stiffer support structures, steel shell deformations of this magnitude are seldom seen. With similar reactions taking place within the interior of the stronger cathode the resulting displacements of lining materials can be similarly damaging. Figure 14 shows the vertical tilt of a filler carbon block in the side lining of a strongly supported steel shell, caused by the upwards movement of the adjacent bottom block. The vedge-shaped gaps formed at the interfaces between the peripheral rammed seam and the prebaked filler and bottom blocks are filled with bath and aluminium carbide.

Figure 14. Forced tilt of carbon side lining filler block following bottom heave in cathode with strongly supported steel shell. The vertical displacement is 7.5 cm measured from bottom corners of filler block. Pot life was 1032 days.

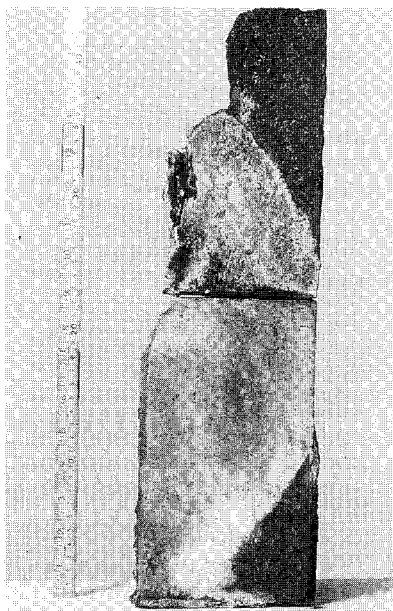
Failures caused by air oxidation of carbon are normally upper sidewall failures (Figure 15), usually resulting in red-hot sides or bath tap-outs. This kind of sidewall failure is usually a function of cell operation, *i.e.* insufficient covering and sidewall protection practice, but poor lining design and bad pot shell conditions may worsen the situation. Unless a good frozen bath and alumina cover is maintained, the upper part of the sidewall carbon may be completely removed in a couple of years. Finally, only a frozen layer of bath may protect the potshell, and a prolonged anode effect may be enough to melt this ledge and cause a tap-out. Figure 16 shows a photograph of a pot that was stopped after the fourth tap-out due to sidewall removal. The first similar tap-out occurred after only ≈ 900 days in operation.

Figure 15. Oxidation (and sodium) damage of sidewall carbon after 262 days in the pot.

This type of failures can sometimes be temporarily repaired by cutting a hole in the deckplate and seal off the tap-out area with ramming paste. Proper covering of the top sidewall with frozen bath and oxide will reduce the rate of oxidation. One or two layers of air and fluoride resistant refractory bricks between deckplate and

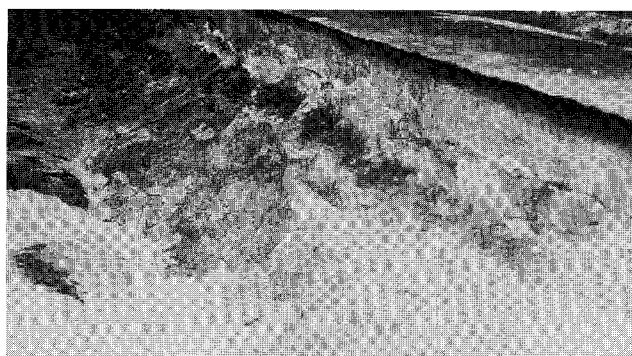
Figure 16. Almost complete removal of sidewall carbon by air oxidation. Pot was finally taken out following its 4th side tap-out after 1486 days, but first tap-out caused by sidewall oxidation took place after ≈ 900 days in operation.

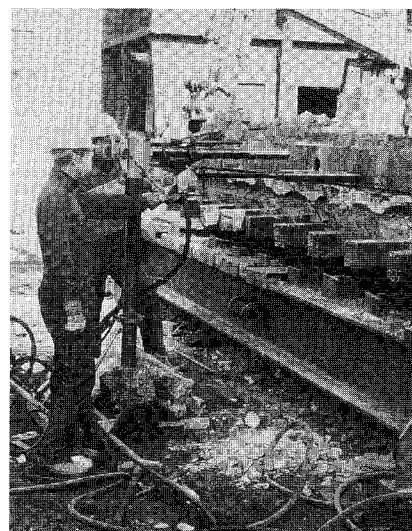
Figure 17. The steel shell side has been removed from a failed pot and an air-burn pattern characteristic of leaky seals can be seen on the carbon filler blocks above the current collector bars. Pot life was 595 days.

sidewall carbon can give an excellent, although more costly, protection of the underlying carbon. High quality silicon nitride bonded silicon carbide bricks will normally give an adequate protection. Air may also find its way behind the sidewall carbon, from the top or through leaks in the collector bar-steel shell seals (Figure 17). In addition to removing sidewall protection from places where it is not readily detectable, such air gaps that are formed between lining materials and the steel shell can result in unwanted insulation effects. As the air usually enters through the collector bar holes, an effective seal will alleviate the problem.

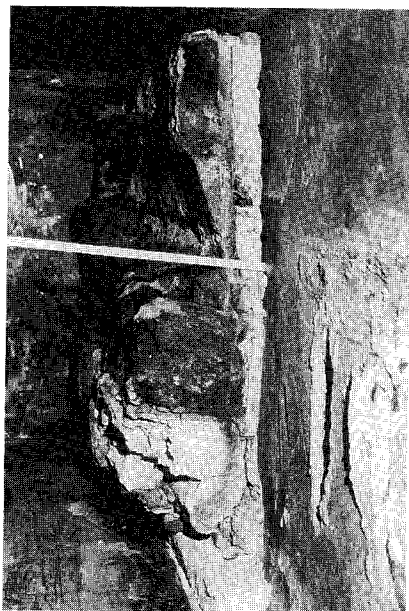
Aluminium carbide has a much higher solubility in the electrolyte than in the metal, and any carbide formed will rapidly dissolve again if exposed to the molten electrolyte. Through loss of protective side ledge the exposed carbon at the metal-bath interface area may rapidly be eaten away by this mechanism due to the normal metal level fluctuations caused by periodically metal tapping of the cell. This carbon consumption has been found to be independent of carbon type and structure [13]. If no side ledge formation takes place a tap-out through the side may be experienced within a couple of months. Figure 18 illustrates the carbon wear caused by the insufficient formation of side ledge by too much insulation between the sidewall blocks and the steel shell (end of pot).

Figure 18. Profile of sidewall carbon block (pot end) that is heavily eroded at metal level and metal bath interface. All bottom and sidewall lining in foreground have been removed. Pot life was 373 days.

A stable frozen side lege will yield the most effective protection of the sidewall carbon while excessive bottom wear will have to be counteracted by adjusting metal inventory or better magnetic compensation.

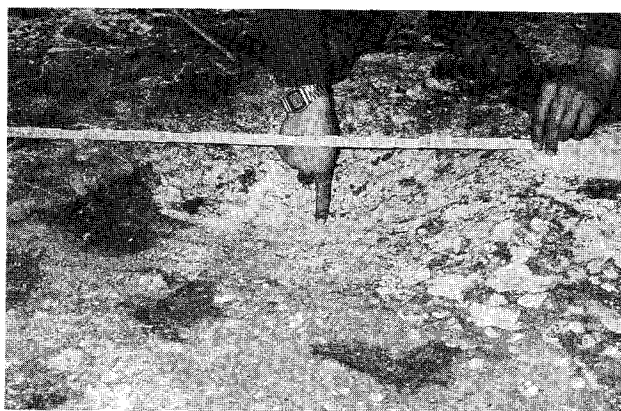
Figure 19. Photograph of cavity under tapping hole in 155 kA prebake cell. Pot was taken out after 1233 days for unrelated reasons.

The photograph in Figure 19 shows an example of surface erosion in the tap-hole area after 1233 days of operation. The cavity shown is much wider than the tapping spout can access. The increased surface wear is probably related to an increased rate of aluminium carbide dissolution from bath that is sucked down and washed over the cathode surface during tapping, and not to any mechanical abrasion and chipping action from rough handling of the tapping equipment.

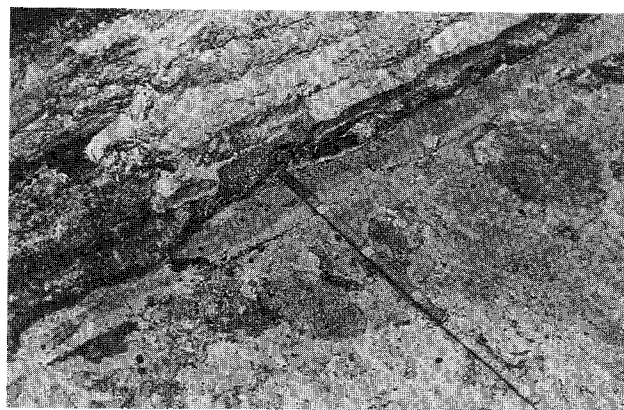
is worn away to be level with the bottom block surface (Figure 20). Since an excess electrochemical dissolution rate of carbon is explained by local higher-than-normal current density or by cathodic carbon exposed to bath, the excess carbon wear in this part of the cell appears not to fit the electrochemical model. The eroded area has always been covered with aluminium metal during operation and the current density has been low. Low current density in this area is the result of several factors: This part of the bottom is outside the anode shadow, there are electrically non-conductive layers of refractories and insulation directly underneath these parts and the electrical conductivity of the ramming paste is much lower than in the prebaked bottom block. More probably the excess wear is due to a higher rate of bath exchange in the fluoride film between the carbon bottom and the metal pad in this area due to higher metal velocities.

Figure 20. Horizontal extension of carbon bottom (bottom blocks in foreground) due to erosion of ramming paste incline. Pot life was 262 days.

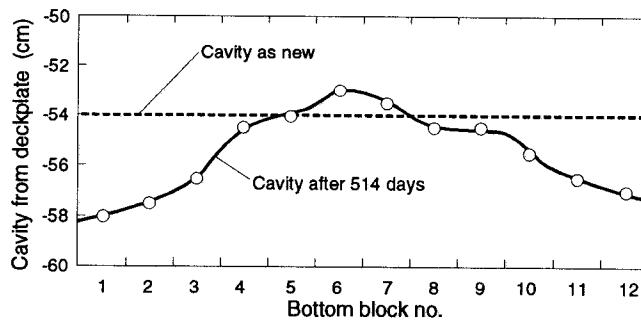
A similar wear mechanism has been observed if the pot has been allowed to run on very low metal levels for extended periods of time. Due to the magnetic forces the metal pad will tend to have a curved surface profile, with a higher metal level in the central part of the cell and reduced thickness closer to the ends. If the total metal inventory is reduced beyond a critical level, depending on operation parameters and magnetic compensation, one of the observed effects is an increased bottom wear towards the ends of the pot. Such excess bottom wear can be explained by an increased rate of aluminium carbide dissolution caused by the increased agitation and rate of bath transport underneath the lower metal pad level towards the ends, but hardly by electrochemical dissolution since the carbon is always covered by the metal pad and there is no increase in current density towards the ends. Figure 21 shows the bottom profile measured along the long central axis of a prebake prototype

Figure 21. Bottom profile measured along the long axis of a cathode. The pot was shut down after 514 days. The cell had been run on only 5-6 cm metal height the last 6 months before shut-down.

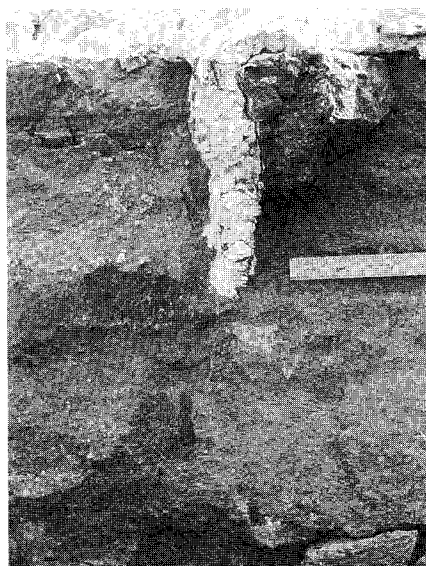
Figure 22. Aluminium filled pot hole in cathode showing a tiny crack that extends from the bottom of the hole further down into the carbon block. Pot life was 207 days.

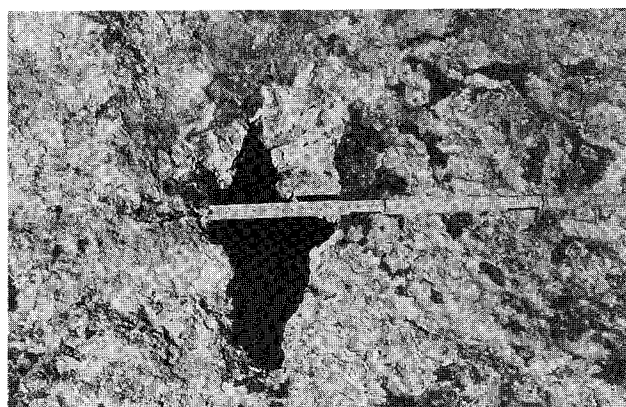
A pot hole may, from the formation and enlargement mechanism described above, extend for the whole width of a bottom block or the length of several meters through erosion of existing cracks and gaps in the carbon lining. Figure 23 shows a fatal pot hole that was initiated from a preheating crack through a bottom block while Figure 24 shows similar pot hole (or crack widening) mechanism having worked on bottom heave cracks in a carbon lining surface.

Figure 23. A pot hole covering the entire width of a bottom block was initiated from a preheating crack through the block. Pot life was 856 days.

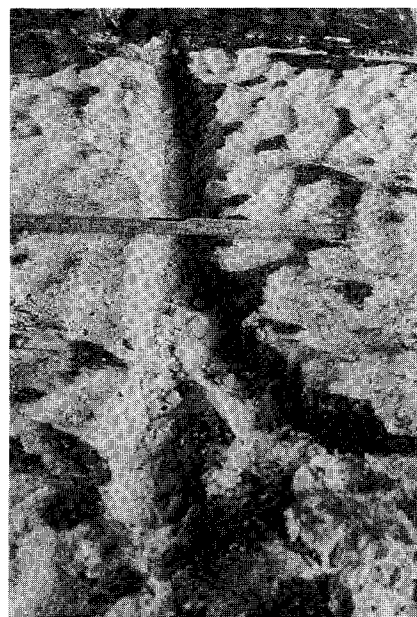
Figure 24. Erosive enlargement of bottom heave cracks in cathode is similar to pot hole formation mechanism. Pot life was 501 days.

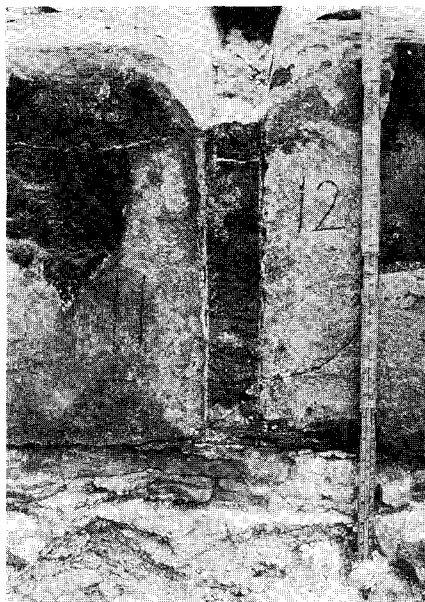
Figure 25. Erosion of the central joint in a cathode with split bottom blocks. Pot life was 595 days.

Cathodes with split bottom blocks (and split current collector bars) and a central rammed joint running down the long axis of the cell are particularly exposed to joint erosion (Figure 25). Since any bottom heave in such a lining is likely to result in gap opening at the central block-joint interfaces, a continued metal penetration and unfavourable local current densities will tend to go on through the entire life of the cell and in some cases be the direct cause of failure.
