MOLTEN METAL SAFETY APPROACH THROUGH A NETWORK

Keywords: Casthouse, aluminum, safety, explosion, approach

Abstract

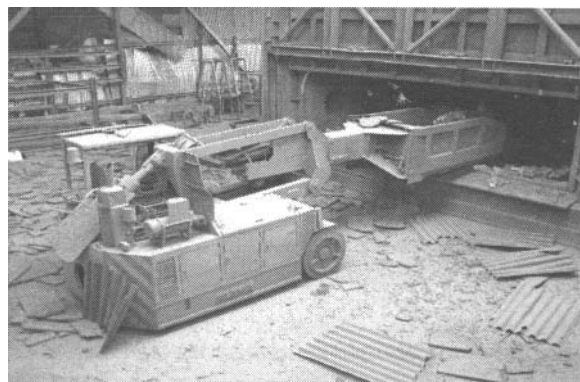
A strong explosion occurred while loading plates and cuts from plate edges into a 50t furnace. One employee, who was operating the loading vehicle suffered 2nd degree burns at his face and injuries to his eyes. Fortunately he regained his eyesight. The ceiling of the furnace was completely destroyed and the roof and cladding of the casthouse building was seriously damaged. The main door of the 50 t furnace had already been opened for at least 10 minutes. The furnace had been emptied half an hour before by the previous cast. A forklift truck operator had filled the bucket of the loading machine with aluminium scrap plates and cuts (alloy 7212) of the fourth container, which belonged to the designated furnace load. The driver of the loading machine was sitting inside the cabin of the loader and pushed the content of the filled bucket

Figure 1: After the explosion in the casthouse.

The further investigation on the site confirmed the hypothesis of a physical-type reaction between water (ice) and molten aluminum in a confined space and the with the generated vapour put under pressure. The explosion intensity may be explained by the fact that there was water in the form of ice. The lower the water temperature is, the more violent the explosion is (Fig 2). The mechanical impacts due to the loading operation could be a factor that trigged off or aggravated the explosion intensity.

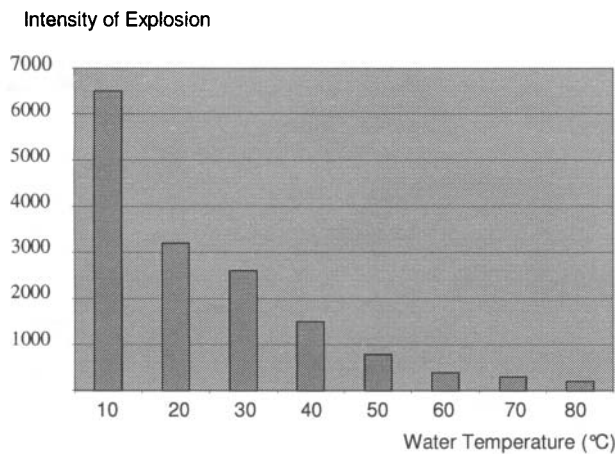
Figure 2 : Intensity of explosion related to the water temperature

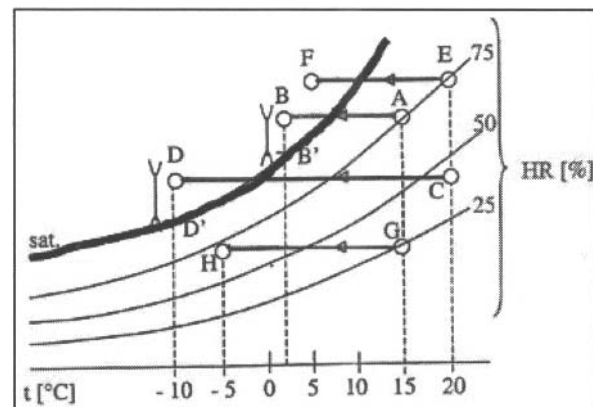
By measuring the temperature of the air, the relative humidity (also called hygrometric degree) and the temperature of the metal, the risk of condensation can be determined using the following figure. From a starting point defined by temperature and relative humidity, there will be condensation if the temperature drops below the saturation curve (Fig 3).

Figure 3: Risk of condensation

Point A: Air at 15°C with 75% HR. Then over night the air temperature suddenly drops to 2°C → Point B Condensation!

Point C: Air at 20°C with 40% HR. Cold metal with a temperature of -10°C is carried into the cast house → Point D – point D Frozen condensed water!

Point E: Air at 20°C with 75% HR. Metal with a temperature of 5°C is moved into the cast house → Point F Condensation!

Point G: Air at 15°C with 25% HR. Metal with a temperature of -5°C is moved into the cast house → point H No condensation

Best practices are: To store all materials inside under controlled conditions preventing condensation, to store alloying materials in a heated room, to unload hardeners under a cover.

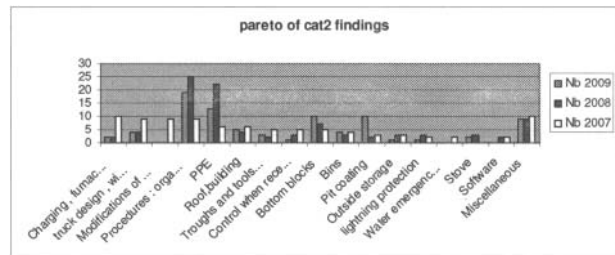
An analysis of the type of findings was made (Fig 5). Many findings were related to the PPE wearing, and to the procedures and their compliance. Many investments were also made to respect the standards, especially of roofs to protect the material and of furnaces to dry it.

Figure 5: Pareto of Category 2 findings
