Hazards associated with the use of bone ash in contact with molten aluminum.

Don A. Doutre

Novelis Global Technology Center, Box 8400, 945 Princess Street, Kingston, Ontario, Canada, K7L 5L9

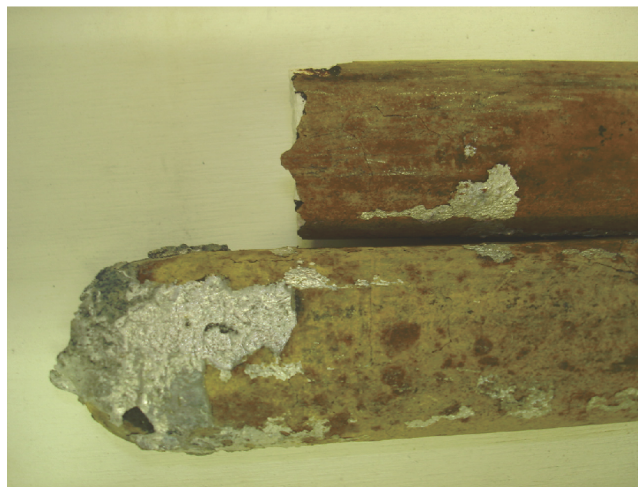
Figure 1: Discoloration and accumulation of material on a bone ash coated flow control pin.

The area of the pin in contact with the metal had changed from pure white to a dark yellow/green brown. A very distinct garlic-like odor was released when the plastic bag containing the sample was opened and the odor became more intense when the sample came into contact with water during sample preparation. Due to the reactivity issue subsequent sample preparation was done using water-free fluids. Figure 2 shows and SEM image of the built-up material. EDX analysis indicated the presence of Mg, O and P along with only traces of Ca.

Indications that there might be issues relating to a reaction between bone ash and molten aluminum began with the arrival of a metal flow control pin that had been used in the casting of an aluminum 4.5% Mg alloy. Fused silica flow control pins were coated by dipping in an aqueous slurry of bone ash prior to drying and use. During casting, material would adhere to the sides of the pin in contact with the molten metal and on occasion the accumulation of material would choke off the metal flow leading to a cast abort. Figure 1 shows a flow control pin with an accumulation of material.

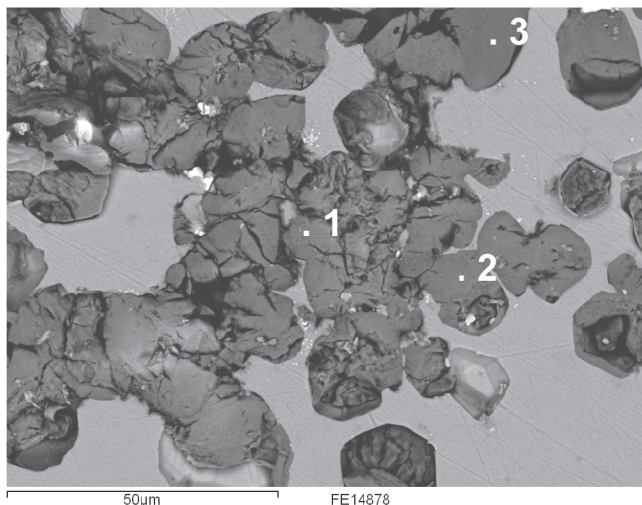
Figure 2: SEM image of a “dry-polished” section through the material adhering to the flow control pin.

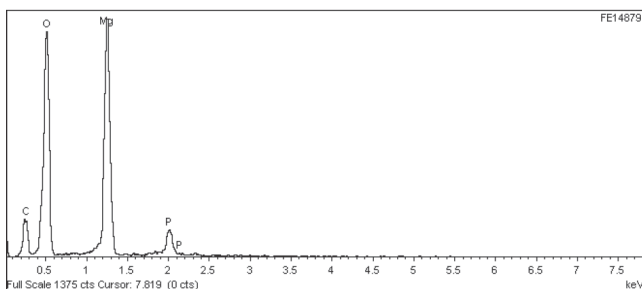
Figure 3: EDX spectrum of particles in Figure 2.

It would appear that, in high Mg alloys the reaction product is MgO, as opposed to MgAl₂O₄. These observations are consistent with the formation of a metal phosphide via the reaction:

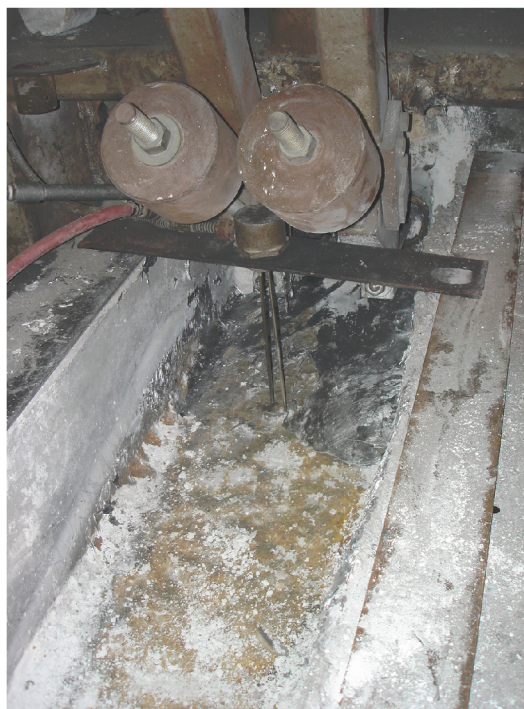
back to the laboratory. Detectable levels of phosphine were later identified inside dross bins and storage areas and in the vicinity of transfer launders where the characteristic yellow/green/brown color associated with the reaction was readily observed (Figure 4).

Figure 4: Discoloration of base of transfer launder due to metal phosphide formation.

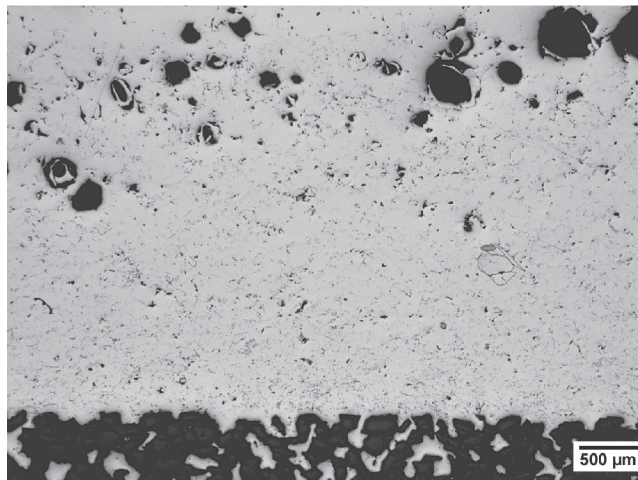
The results indicate that all of the materials react with the alloy to some extent under the conditions of the test. In addition to a large increase in the calcium level, the metal exposed to bone ash gained 29 ppm of phosphorous. Even exposure to boron nitride, a substance generally regarded as inert to aluminum alloys, led to a substantial increase in the boron content of the metal. The fact that bone ash and wollastonite had been used successfully in this application for many years was used as a de facto standard against which the other materials were evaluated. Figure 3 shows an image of the PoDFA concentrate of metal exposed to wollastonite.

Figure 3: PoDFA concentrate of Wollastonite exposed to AlMg5

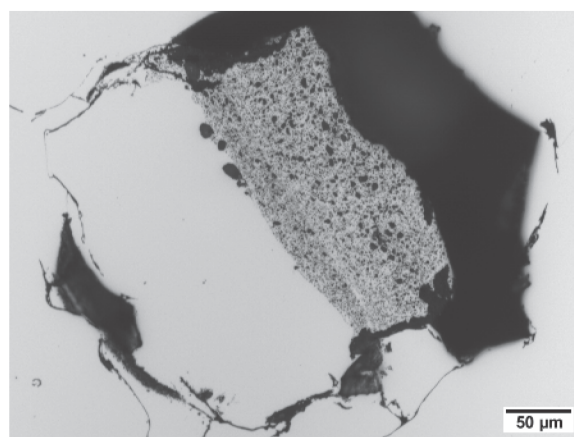
On this basis mica wash and talk were eliminated. Other materials were discarded based on cost and availability. Another factor used in determining suitability was the tendency for the materials to form clusters either by infiltration or reaction and clumping. An example of this behavior, seen in a PoDFA concentrate of a sample exposed to kaolin is shown in Figure 4. Clusters of inclusions of this size are of obvious concern in inclusion sensitive applications.

Figure 4: Infiltrated clump of reaction products seen in a PoDFA concentrate of metal exposed to kaolin powder.
