# Light Metals 2014

**ELECTRODE TECHNOLOGY FOR  
ALUMINUM PRODUCTION**

## IMPROVING ENERGY EFFICIENCY AT ALBRAS: A CASE STUDY IN THE RODDING SHOP

Paulo Douglas S. de Vasconcelos<sup>1</sup>, Marcelino Pascal Rodrigues Vasconcellos<sup>1</sup>, José Fernando Nunes<sup>2</sup>

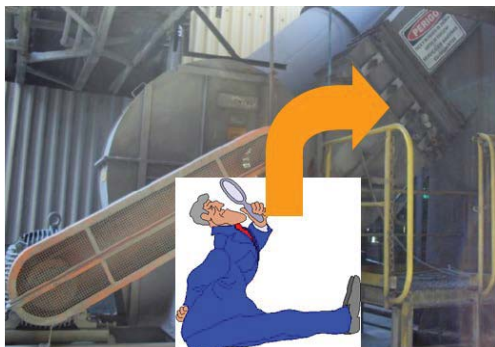
Figure 1 – Exhauster's damper to adjust the volumetric air flowrate of the baghouse.

The electrical energy was subsidized for Albras from the start up in 1985 to 2004. In this period, the engineering department improved the workplace environment and the pouring station capacity by installing electro-intensive baghouses and two induction furnaces of 1 MW in the rodding shop. To support this upgrades, the local substation was repowered from 3 MVA to 6.7 MVA. The electric motors of the baghouse exhausters of 110 kW with softstart drives controlled the motor start-up but did not control the volumetric air flowrate of the baghouses. Therefore, the dedusting of the workplace was adjusted via the exhauster damper as shown in figure 1.

- ✓ Lack of a speed controller (using manual dampers) to start and adjust the volumetric air flowrate and the power demand of the baghouses – figure 1(**project**);
- ✓ Low reliability and availability of the induction furnaces (**maintenance**);
- ✓ Lack of an educational program/campaign to encourage the rational use of electric energy including lighting (management);
- ✓ Lack of confidence of the operation crew who has to operate the plant with only one induction furnace (management).

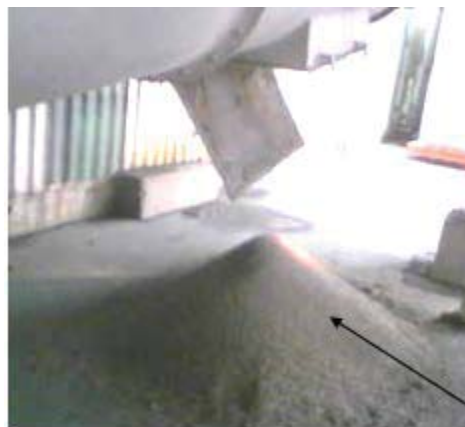
Figure 2 – Clogged pipeline due to lack of intelligent control of the exhauster's baghouse.

Even after installing eight huge baghouses in the two rodding shops, demands of operators continued for better workplace without pollution, especially, the pouring station receiving cast iron from the induction furnaces. These issues were related to the conception of the original projects. The pipeline of the baghouse that dedusts the shot blasting machine, autogenous and roller mills became clogged from time to time due to deposition of coarse particles collected at the hood as it can be seen in figure 2.

After the installation of the speed controller in the baghouse, the maintenance problem was eliminated, the workplace ambience was improved, and the air velocity inside the pipelines was increased. Consequently, clogging problem in pipelines, shown in figure 2, was solved. In addition, the power demand was cut by half which resulted in saving of 55 kW. As shown in figure 4, the electric motor was running at 60 Hz (upper circle in figure 4)

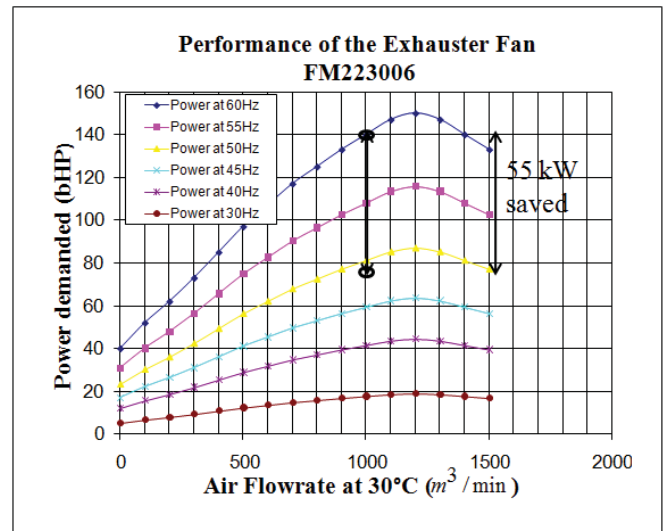
Figure 4 shows the power requirement of a baghouse exhauster (FM 223006) versus the volumetric air flowrate. Using the law of similarity for the fans, it is possible to correlate the power requirement and volumetric air flowrate with the output frequency of the speed controller:

Figure 4 – Exhauster curves controlled by a speed controller – PID controller [2].

The volumetric air flowrate of this baghouse (FM 223006) was measured as 1000 m³/min using a Pitot tube shown in figure 5. So, the power demand was obtained using the equations (1) and (2) and the Microsoft Excel, and shown in figure 4 for the frequency range from 30 Hz to 60 Hz [3]. The manufacturer of the fan supplied the calibration curve of the exhauster (FM 223006) at 60 Hz.

before the installation of the speed controller and it is running at 48 Hz after the installation of a PID controller with set point adjusted to 50% of the motor nominal power rate (110 kW).

installing the speed controllers in five baghouses with 110kW motors as it was explained in the previous section (figure 4).

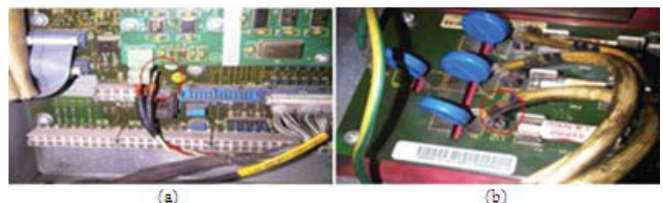
Figure 10 – (a) Disconnected cable in the voltage feedback card, (b) Bad contact in the surge voltage card of the rectifier.

In the first overhaul, potential source of problems was found to be a faulty connection in the card that measures the voltage feedback of master rectifier as can be seen in figure 10.

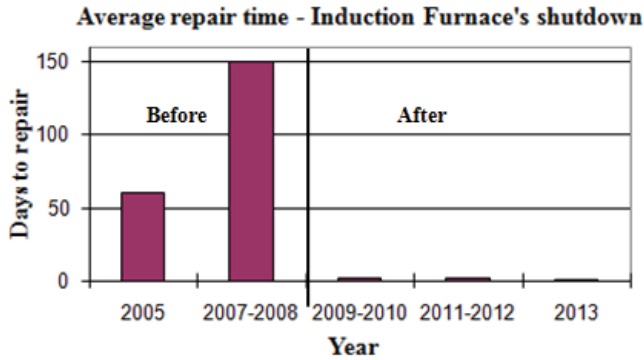
Figure 11 – Shutdown in the Albras' induction furnace.

Figure 11 indicates the increased reliability of the induction furnace after the improvement of the NAMC card and the new maintenance strategy. According to this strategy, the main goal is to educate the technicians and operators so that they are conscious of the fact that they must do their best to eliminate the waste of raw material and electrical energy for Albras to stay competitive.

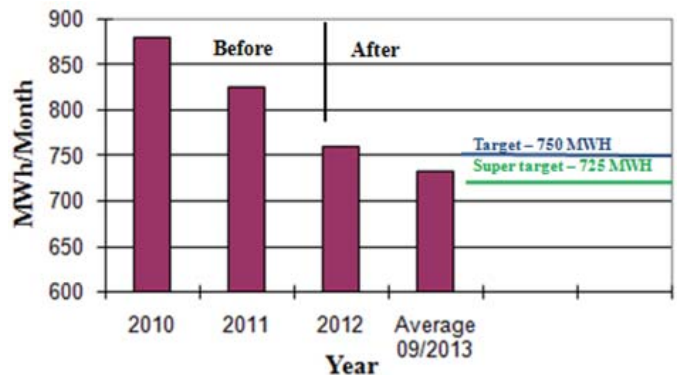
Figure 13 – Electrical Energy consumption in the Albras' rodding shop between 2010 and 2013.

The energy consumption decreased from 879 MWh/month in 2010 to around 725 MWh/month in 2013 as it is illustrated in figure 13. This shows that a suitable solution was found for the problems of the induction furnaces and the baghouses by

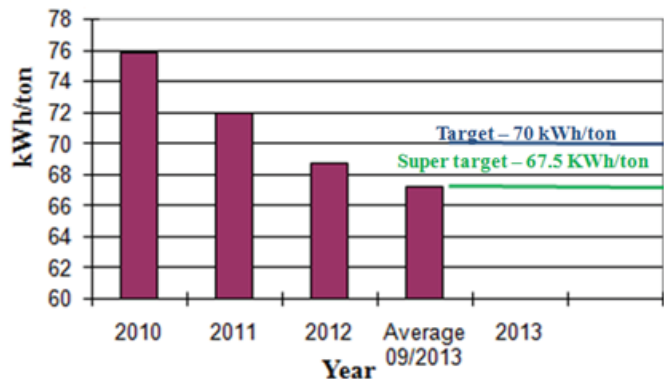
Figure 14 – Specific Electric Energy consumption (per anode) in the Albras' rodding shop between 2010 and 2013.

Figure 14 correlates the specific energy consumption with the productivity of the process, thus, shows the improvement in the energy efficiency. This is mostly due to the improvement of Albras' rodding shop which resulted in reduction of specific energy (per anode) from 75.8 kWh/ton in 2010 to around 67.5 kWh/ton in 2013.
