## Graphite Cathode Wear Study at Alouette

### **Abstract**

Between 1996 and 1999, graphitized cathodes were installed in the 264 AP30 pots at Aluminerie Alouette Inc. aluminum smelter. During this period, an extensive cathode wear study was undertaken with the primary objective of predicting potlife.

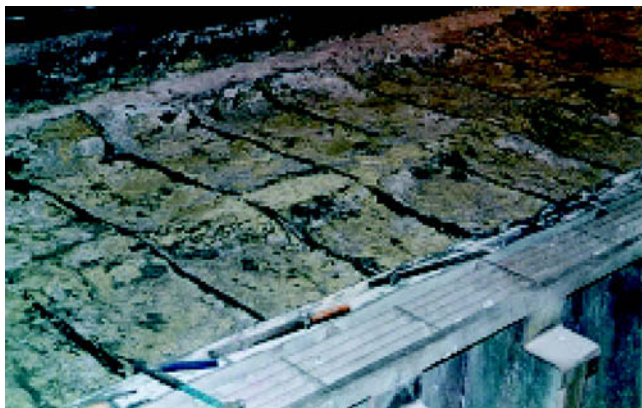
Figure 2: Cleaned surface of the graphite pot before delining.

Validation of measurement accuracy was done by comparing wear measurement taken with the live pot and comparing them with the real value taken during the delining of the same pot. So far, only one pot was stopped for validation. Results show that the wear measurement are within 1.5 cm of the real value.

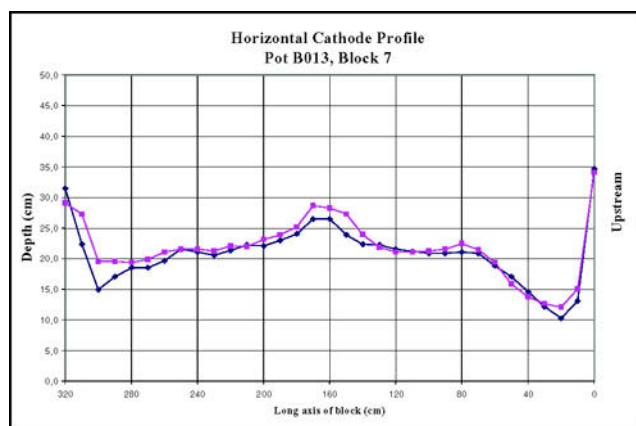
Even when measuring young (less than 500 days old) pots, the well-documented W wear pattern (6,7) showed up clearly as shown in figure 3a. Figure 3b represents the wear observed across the cathode blocks, showing the U pattern typical of cells where cathode blocks are joined by ramming paste. As already mentioned (6), the very presence of this shape indicates that mechanical abrasion possibly caused by the crust grab used at Alouette and other AP30 smelters is not the main wear cause otherwise, the ramming joints would have been shaved off.

Figure 3a : Typical wear profile showing the wear pattern.

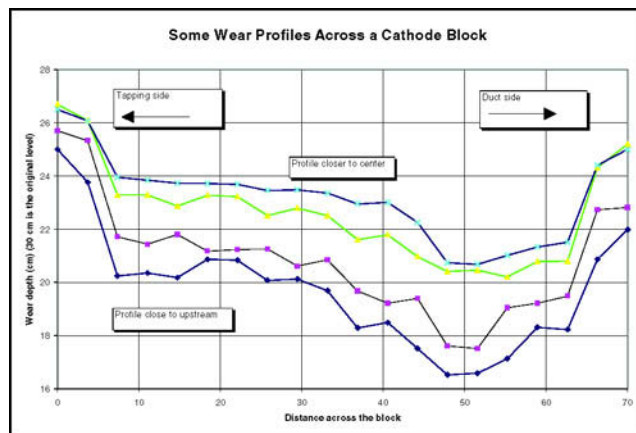
Figure 3b: Section across the short length of a cathode block.

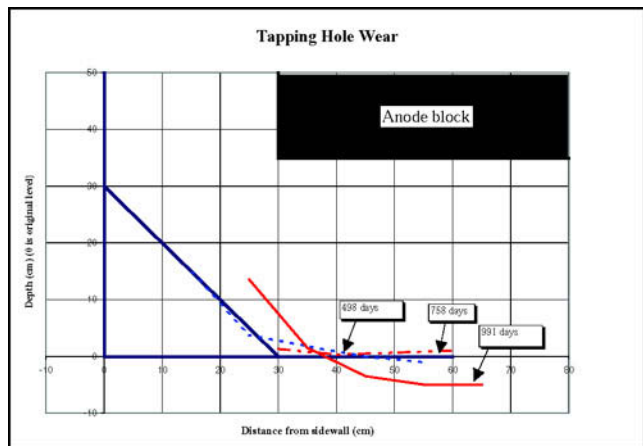
Tapping hole measurements also showed that the mechanical erosion feared at this particular location does not happen at a critically high level. The wear rate there is minor compared to what was observed elsewhere in the pots. This corresponds with other observations (4) since the AP30 pot operates with low metal pad velocities and medium metal depth. See figure 4.

Figure 4: Tapping hole wear profile for pots of different ages.

- 4- Tap hole wear is not the main potlife threatening factor with high amperage graphite pots. High speed wear is concentrated on the side of the pots, and is fastest on some well-defined blocks, independently of the block type.

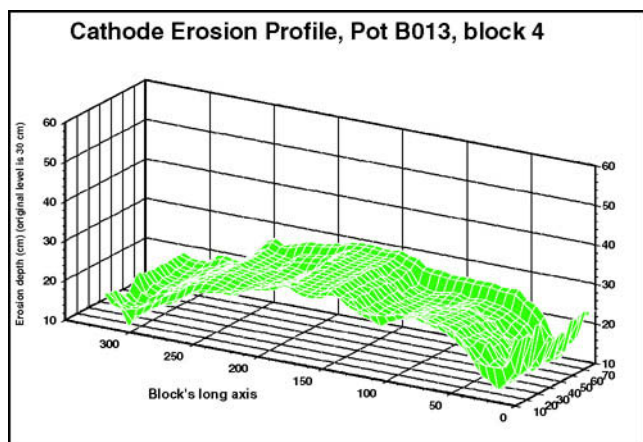
Figure 5 shows a representative topography of one cathode block of the stopped pot. This general wear profile predicted by pure electric models based on the current density theory to explain wear rate (7) still does not apply evenly to all parts of the pot. Interesting local deviations from the general trend constitute more hints that wear rate is indeed strongly driven by current density.

Figure 5: Typical wear topography of a cathode block.

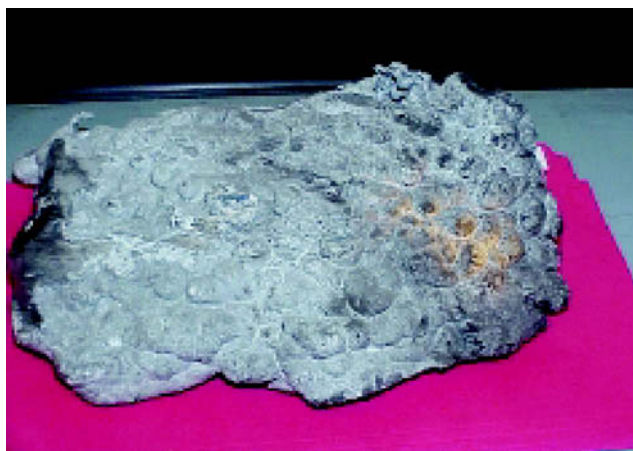
- 3- A fascinating observation of the eroded surface of a stopped graphite pot may give some clues about the involvement of mechanical erosion in the overall wear process. As shown in figure 7, the surface of the eroded graphite bears numerous small rounded holes 5 to 10 mm deep. These holes are not expected from a purely chemical-wear phenomenon, which tends to smooth out surfaces. Since the holes are not detached particles from the matrix (they are rounded through all matrix grains), some microscopic mechanical eddy-like erosion process may be at work. Despite the fact that sludge is not a problem with AP30 pots, it is quite possible that alumina particles spend some time in the deep cavities of the W trough and abrade the carbon while being transported by small eddies in the metal. As pointed out by Øye and Welch (5), both chemical and mechanical wear mechanisms seem to erode carbon.

Figure 7: Surface of the metal leftover peeled off the graphitized cathode of the stopped pot: the molding shows the holes on the cathode's surface.

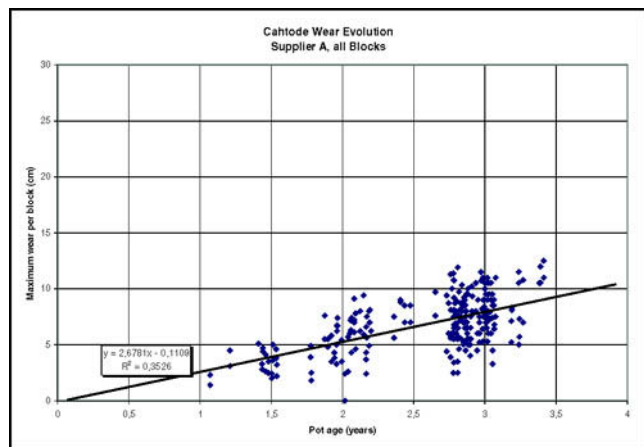
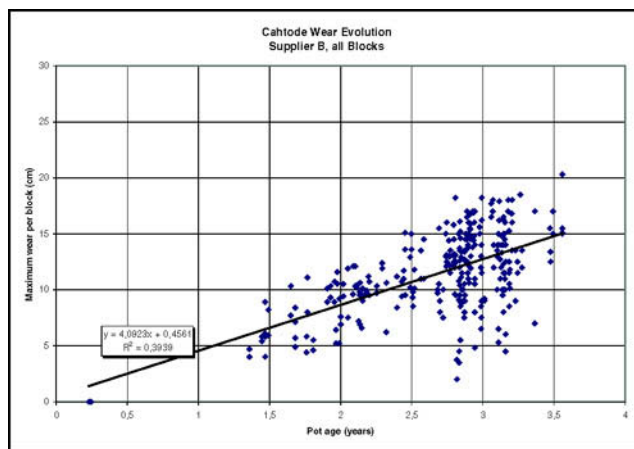
Experience with phase 1 measurements and the stopped pot showed that fortunately the cathode is wearing faster at a convenient place for measurement, that is, close to the side of the pot. Figures 8 and 9 present typical results from these measurements for two cathode block types. Every wear measurement taken for the various high-speed wear blocks of the population pots are plotted against the age of the pots when measured. Despite a very high scattering of the data, evident differences of regressed wear evolution were observed between different cathode block types. Still, the high scatter made it very difficult to use these results for potlife prediction, since wear average and standard deviation at a given age would result in a standard deviation of the same order of magnitude as the potlife itself. This result is not satisfactory since operating experience of other smelters using graphitized cathodes with AP30 technology showed that potlife standard deviation is much smaller with graphitized blocks than with semi-graphitic blocks. Indeed, while semi-graphitic pots have potlife standard deviations around 400 days, graphite pots have around 100 days. This high scatter is at least partly caused by the location-dependent wear rate observed in the pots. Computed regression lines pass very close to the origin of the graph naturally, without "help" from parameter adjustment.

Figure 8: Wear measurements for a population of pots with supplier A cathode blocks.

Figure 9: Wear measurements for a population of pots with supplier B cathode blocks.

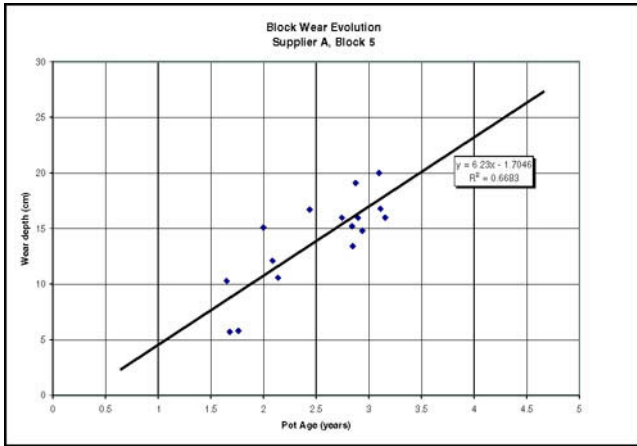
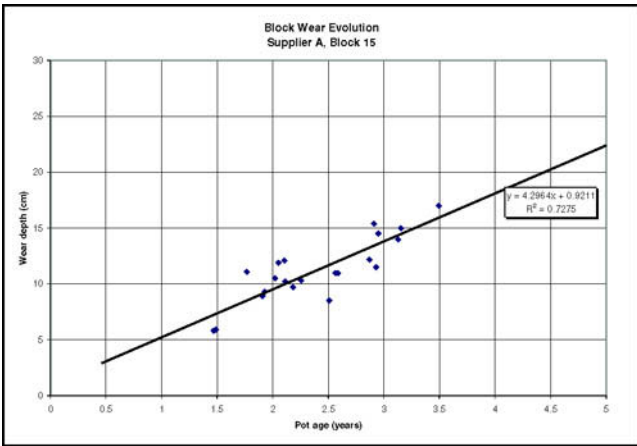
A "block-by-group" study showed that within a given block type, plotting wear data for each block location of the pots produces graphs which have much higher determination coefficients, typically above 0.6. Figures 10 and 11 show examples of block-specific wear evolution for a given block type. The scatter is still too high to allow an analysis fine enough to tell between constant, decreasing or accelerating wear rate over time.

Figure 10: Wear rate evolution for block 5 upstream of the supplier A population.

Figure 11: Wear rate evolution for block 15 upstream of the supplier A population.

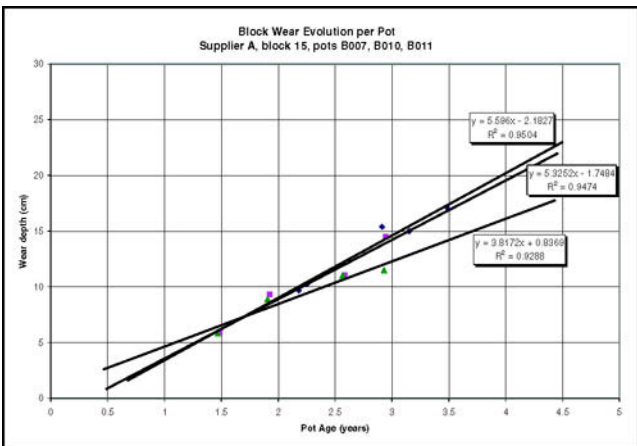
Figure 12: Individual wear rate evolution for block 15 upstream of three supplier A pots.

A "block-by-pot" study explains the scatter of the "block-by-group" graphs. As can be seen in figures 12, 13 and 14, taking maximum wear data for a single block from a single pot at various ages produce regression curves which are straight lines having very high determination coefficients, typically above 0.90. Figure

12 shows that the same block location in three different pots can wear at a rate varying by as much as 30%. Cathode bar current loads are well correlated with these wear-rate variations, but the initial cause remains unknown. Figure 13 represents an evident case of cathode heave, while in figure 14, spalling at start-up shows itself when regression line suggests that the cathode was already lacking almost 6 cm at zero age. Commonly, regression lines show a little heave with graphitized cathodes, and very linear wear evolution up to 1 200 days of age.

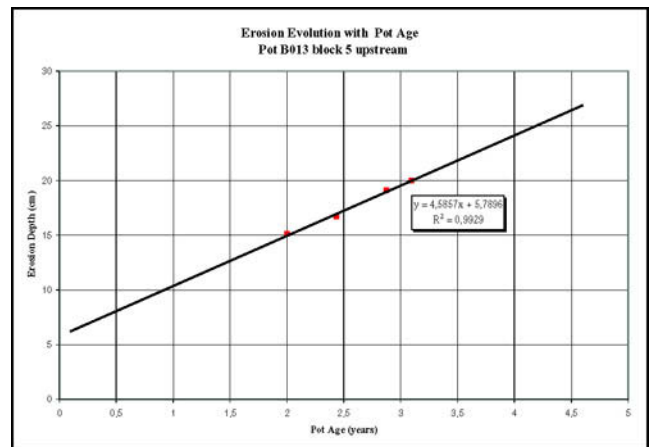
Figure 14: A case of known cathode spalling at start-up.

- 3- Cathode spalling at start-up is easily put in evidence when the regression line hits a positive value at zero age: it means that some carbon was already missing from start; this is, of course, a potlife decreasing factor since the slope of the wear curve is the same as for unspalled blocks at the same location in other pots.

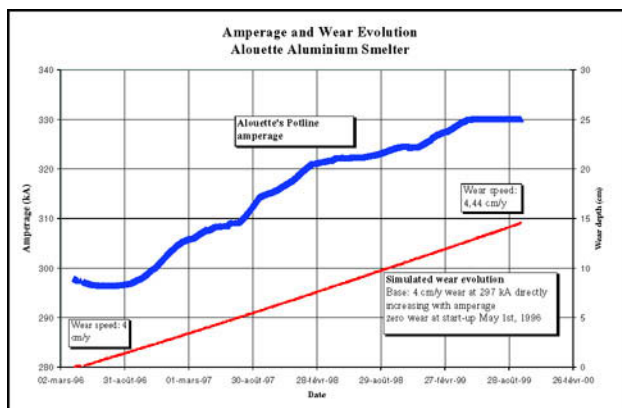
One possible cause of non-linear wear evolution is pot amperage variation, since wear is strongly dependent on current density. As it turns out, potline amperage, even if it varies by 10% or more, affects wear depth evolution very slightly: simulation (figure 15) showed that with wear rate directly proportional to amperage, this effect would be very hard to measure at Alouette, since the resulting curve is extremely close to a straight line.

Figure 15: Wear-rate simulation showing that even a 10% amperage increase is not visible on a wear depth vs time graph.
