**ELECTRODE TECHNOLOGY FOR
ALUMINUM PRODUCTION**

ANODE STUB 3D INSPECTION SYSTEM

Keywords: Anode Stub, Inspection, Anode rod Tracking, process Monitoring

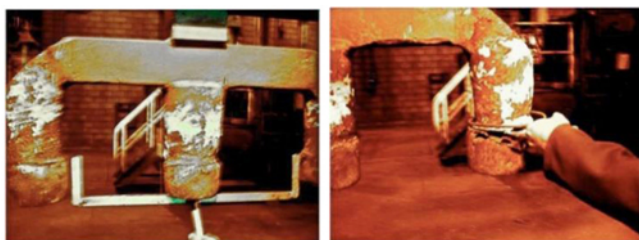
Figure 1. Manual gauging

Anode rod inspection, whether manual or automatic, is an essential activity to ensure the proper operation of the rodding shop and of the electrolysis cells. Traditionally, anode rod inspection was limited to a visual check by an operator as well as some manual gauging as shown on Figure 1. The visual check would allow to send to repair rods with eroded, missing or bent stubs, and gauging would ensure that the alignment of the stubs allows the sealing of the rod in a new anode.

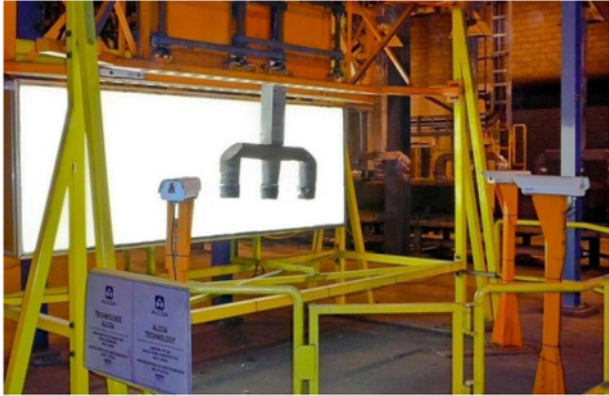
Figure 2. Tripod transit in STAS’ 2D system

collaboration with Alcoa, developed such a system for single plane stub assemblies. The STAS ASIS-2D system [6] (shown on Figure 2) is installed at Alcoa Deschambault’s smelter and has been running since 2006, relentlessly measuring some 400 AP-30 tripods a day. Still, 3D systems were not available to the industry, although some attempts have been made by a few companies to measure hexapods.

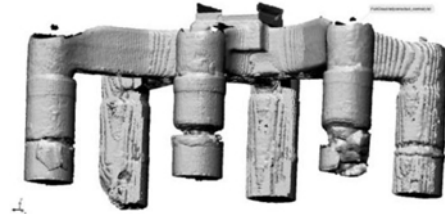
Figure 3. Typical scanner output of ASIS^{3D}

The ASIS^{3D} scanning unit is built around multiple cameras and laser planes. The camera/lens assemblies are designed for a long stand-off and a deep field of view. The sensors allow us to configure the digitizer so that the cameras never get in the path or between the legs of the hexapods. There is no sensor placed under the path of the hexapod either. This prevents damaging the system if some cast iron falls or if a clad gives up during the measurement. Figure 3 shows a typical hexapod scanned using the ASIS^{3D}.

To verify the accuracy of the system, we used a modified hexapod that mimicked a new and straight exemplary that allowed us to take precise manual measurements. The rather worn-out exemplary shown in Figure 3 was just not suitable for investigating the accuracy of the system. We measured the distances from stub to stub and the stub diameters. Table 1 contains the results of the diameter measurements as shown on Figure 6.

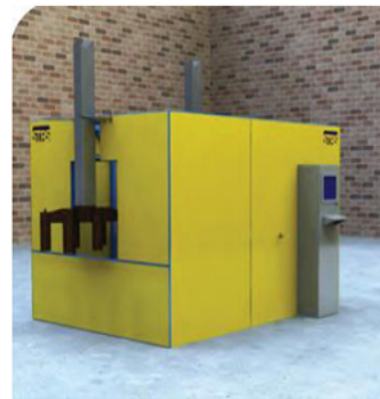
Figure 4. ASIS^{3D} system

The system uses class 3 lasers installed in a fully opaque enclosure (Figure 4). Access to the scanning area is restricted by interlocked doors that prevent the operators to enter the machine while it is in operation. With all the security systems in operation, the equipment becomes a class 1 laser product, which means it is safe under all conditions.

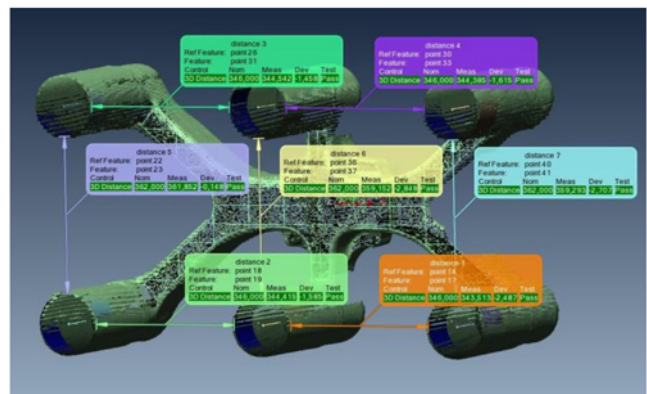
Figure 8. Stub to stub distances

The following table shows the results for the stub to stub distances. We measured the stubs from edge to edge to ensure we could compare the manual and automated measurements directly without any further mathematical operations.

Stub to stub distance (mm)		Offset
Measured	Scanned	scanned-manual
Longitudinal		
345	344.5	-0.5
346	345.4	-0.6
347	345.5	-1.5
345	345.4	0.4
Transverse		
361	360.3	-0.7
362	360.2	-1.6
362	362.9	0.9
Average		-0.51
Standard deviation		0.91
